DEVELOPMENT OF SPUTTERED TECHNIQUES FOR THRUST CHAMBERS

TASK I - FINAL REPORT

Pratt & Whitney Aircraft
Division of United Aircraft Corporation

NASA-Lewis Research Center
Contract NAS3-17792

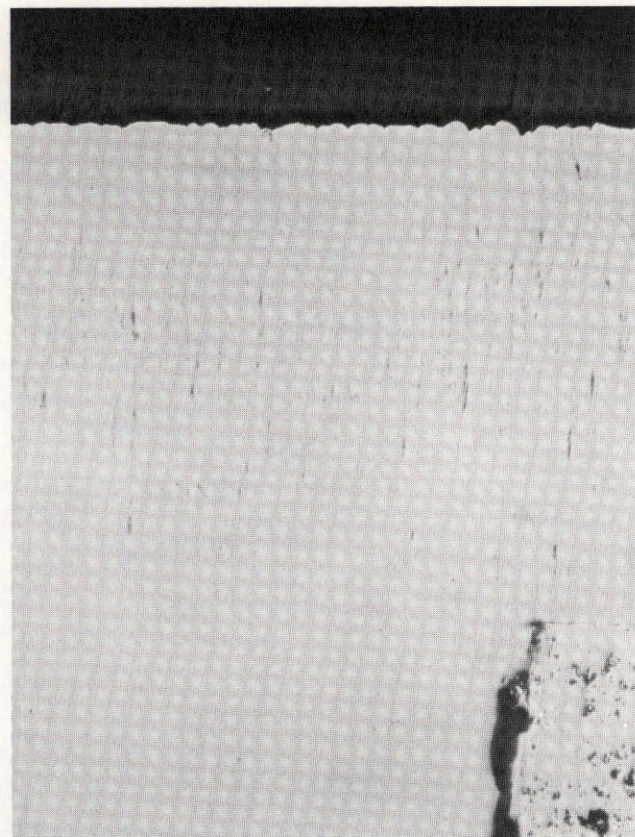
Figure 12. Appearance of Closeout Layer on Dry Machined and Sanded Substrate, Run I-20

Suspecting that the machining lubricants trapped in the filler material during milling also contributed to the crack formation through the introduction of contaminants, dry milling was used in run I-19. Though the outgassing rate of the aluminum filler was significantly reduced, the cracking problem persisted. Dry machining using a reversing cutting technique resulted in minimal cracking at the rib wall and reduced the extent of cracking in the closeout layer. (See figure 12.)

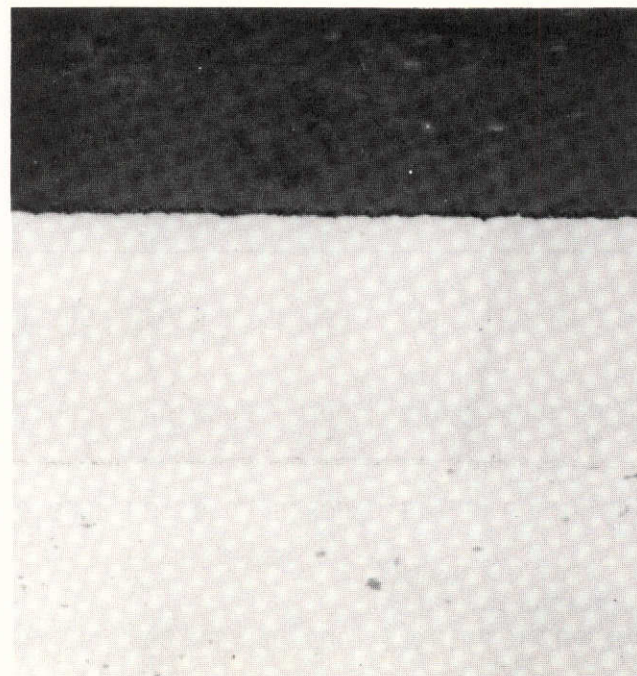
Figure 19. Microstructure of Sputtered OFHC Copper on 600-Grit-Sanded Region of Type 6061 Aluminum Alloy Substrate

The defects probably resulted because of the deposition rate difference between the concave regions and the convex regions. The concave regions exhibited a lower growth rate since these areas were exposed to a smaller segment of the cylindrical target (shadowing effect) than the convex regions. As the deposition continued, the difference in growth rate increased, resulting in deeper and deeper "valleys." The junction between the coating on adjacent "hills" eventually became a sharp cusp moving outward trailing a thin crack or open boundary. The vapor-blasted area exhibited the same effect, but with fewer resultant defects. (See figure 17.) This may have been due, in part, to the contamination at the interface, attributed to the vapor blasting process. It should be noted that vapor blasting usually resulted in a clean interface, (figure 18), so that the above result was not taken to indicate that vapor blasting should be discontinued. However, the preparation by sanding with 600-grit SiC paper resulted in a defect-free structure, smooth deposit surface, and a high quality interface. (See figure 19.) Hence, sanding was the preferred preparation technique for the latter runs.

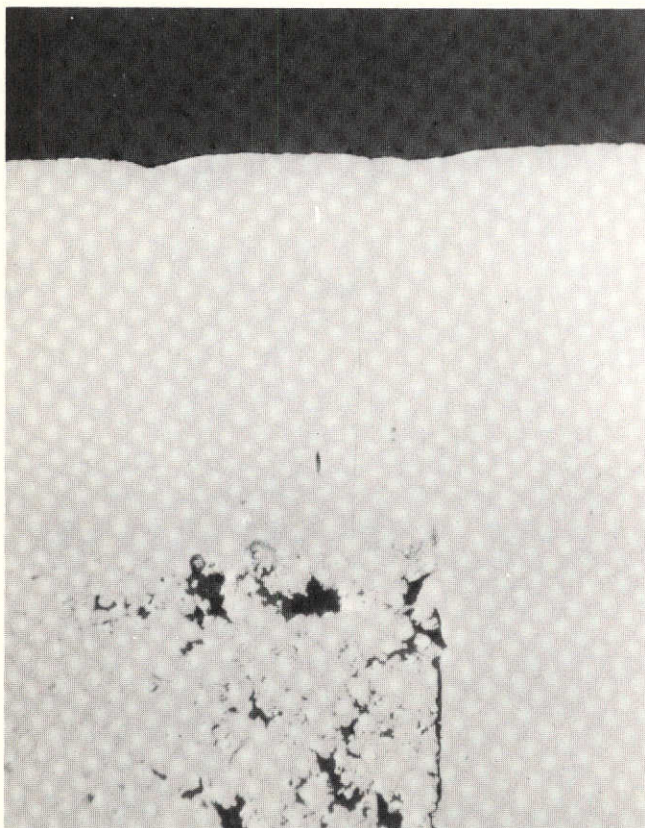
Figure 30. Microstructure of Closeout Layer Applied Using Lower Discharge Pressure, Run I-24

Based on the results of Thornton,⁽⁹⁾ lowering the sputtering gas pressure should permit the use of higher deposition rates without obtaining the characteristic open structures at the low deposition rates required by the OFHC copper substrates and/or the low melting point filler materials. Although the one run (I-24) performed with a lower discharge pressure did yield a closeout layer with fewer defects (figure 30), the improvement in quality could not be attributed solely to the lower pressure since several of the other parameters were also changed.
